1 Lockett Miners' Lodging.  
for full sized photos, see 'Miners Barracks photos 1 - 42'

1. Sketch Plan and elevations

2. Description of the building –

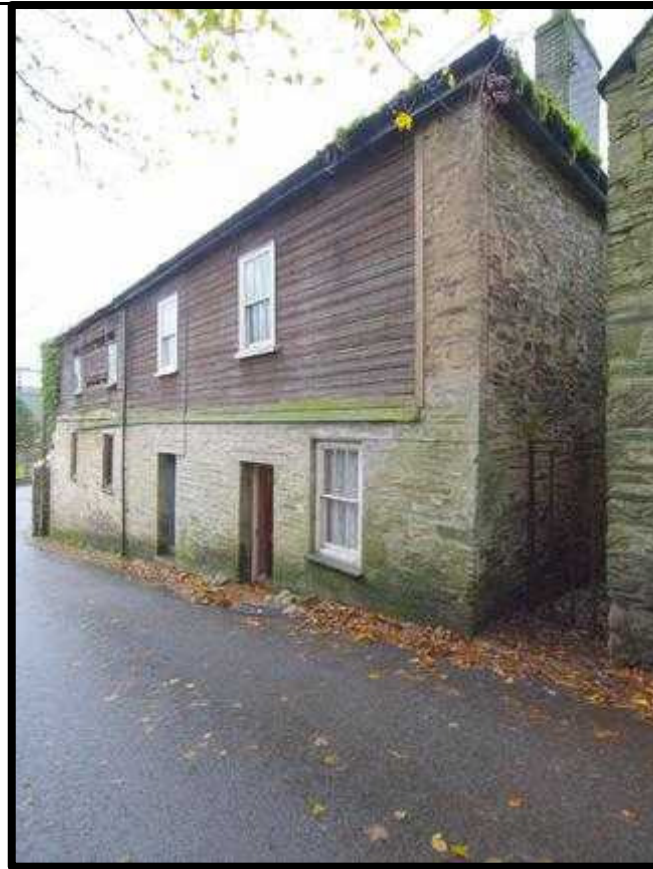
The building has two doors, opening straight centre of the village. The upper door was for family, the lower for the miners. Two doors at the the mine site. It was built by the mining company the mine for production, processing and refining early 1870's. Following the end of the copper and arsenic production became vital to the Cornish was one of the largest producers of arsenic, people. In this remote rural landscape, stretched to over-bursting. Male miners lodged their families for Sundays. It was built for 20 housed 50 men working in shifts, sleeping in one amongst all their arsenic dust and grime, and eating downstairs. The lodging-keepers' kitchen and living with pasty tins hanging all around it, miners. A granite trough in the same area may bring in clean water. Conditions in mine barracks be unbearable; this may have been better. This survivor. No other mine barracks are believed to archaeological remains or foundations (eg two on by scheduling as Ancient Monuments). This is not building, but has been in the same family for four which time it has not been altered; the large been unused and so have deteriorated but are showing the character, atmosphere and conditions extraordinary survivor of the social history of the
